FIELD CHANGE ORDER

OPTIMUS 50 / 65 / 80 RAD – R/F

Error combination 00XI + 00M3

Modification of the PCB High Speed Rotor Control EY 100

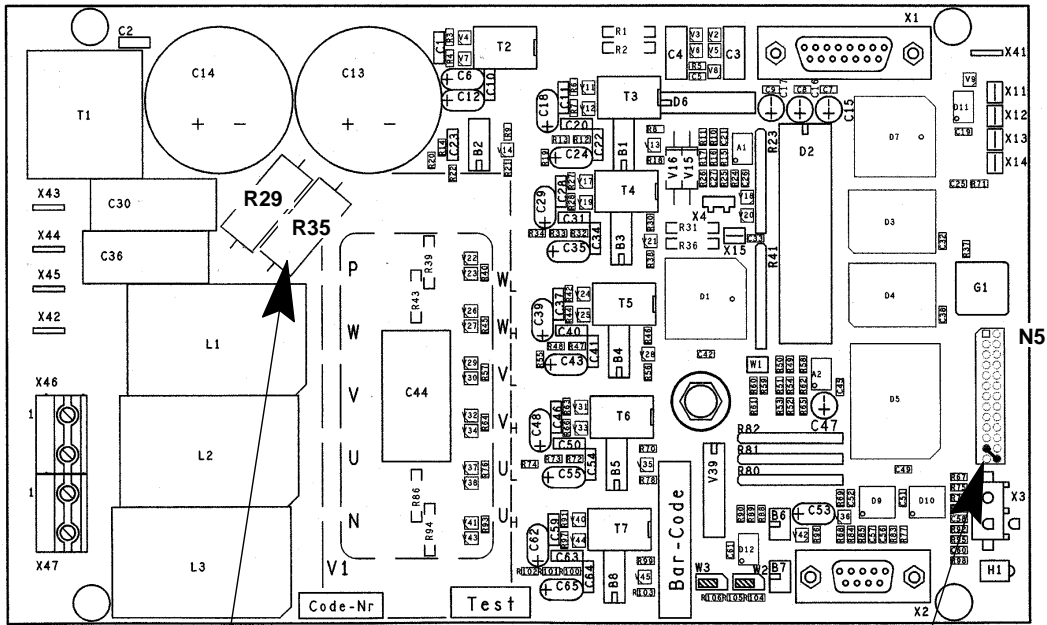
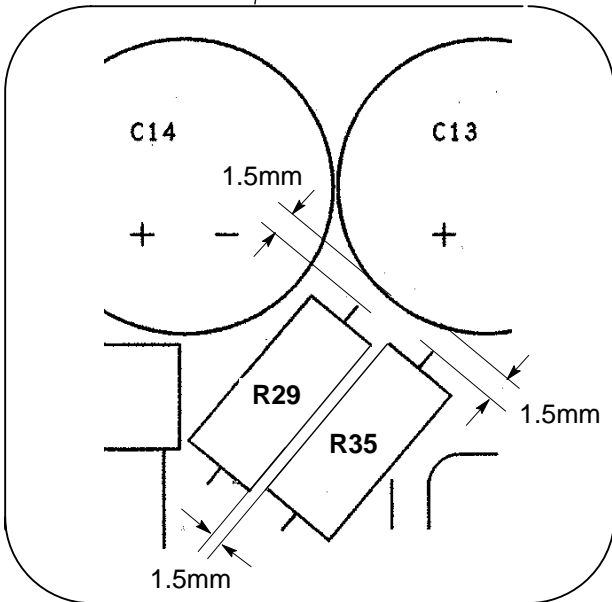
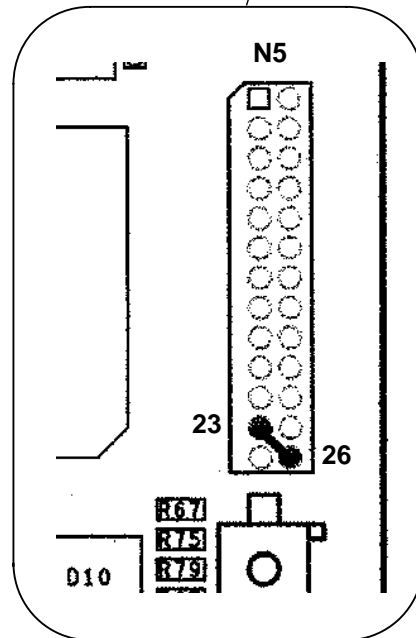
The processor on the rotor control has a debug port. One of the signals is not connected to a pull up resistor. The floating signal leads to the error combination 00XI + 00M3. It happens only once during turn on, not during normal operation.

3. Check that the connecting wires of resistors
R29 / R35 have a distance of at least **1.5 mm** to the
capacitors C13 and C14.

Also between the resistors itself a gap of **1.5 mm**
is necessary. see sketch (page 3)

When the resistors come in contact to the capacitors or
have mechanically contact to each other this can lead to
a shortcircuit and defect of the rotor control.

1. Switch Off the generator.
2. Open the Rotor Control unit,
(back side of generator cabinet)
– solder a link between N5:23 and N5:26 of the
EY 100 PCB. see sketches (page 3).
